# Situation Report No. 1

## Budhi Gandaki Flood, Gorkha District, Nepal

As of 11 October 2026 (Asoj 25, 2083), 10:30 NPT

Prepared by Bagmati Welfare Society Nepal (BWSN)

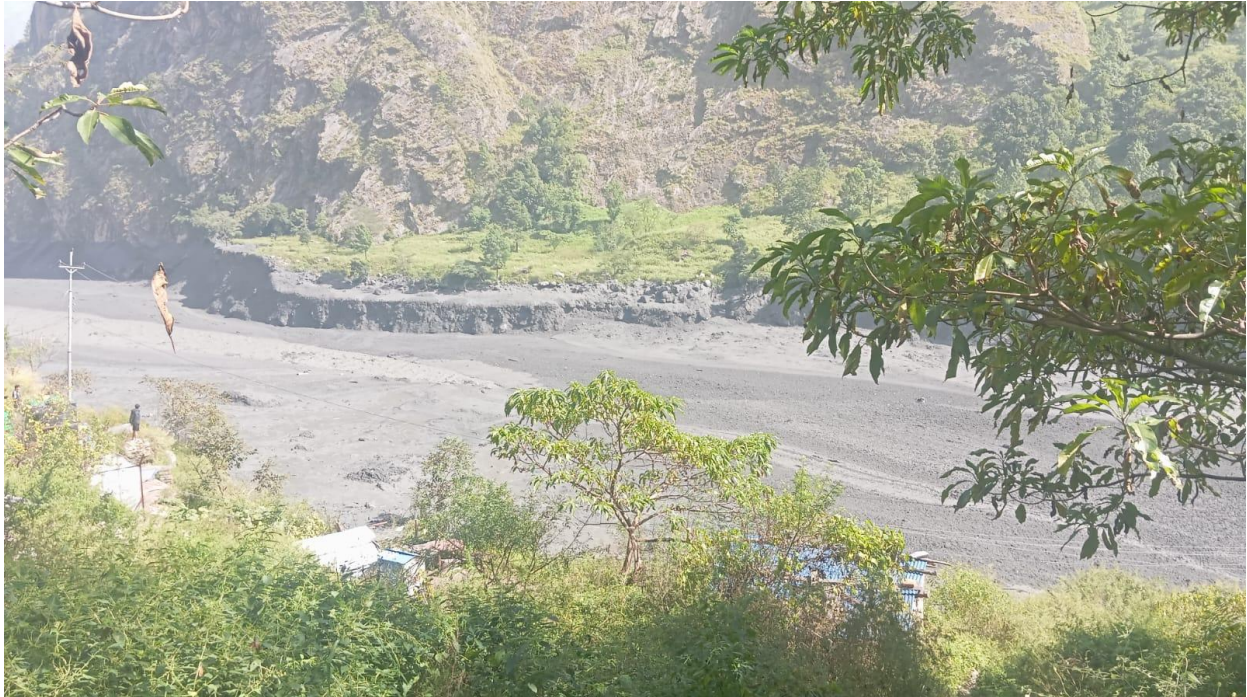
*Photo 1. Riverbed buried in grey debris below a settlement, with houses at the edge of the deposit.*

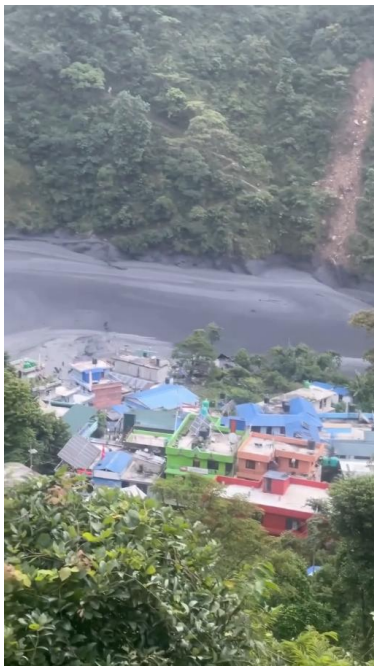
*Photo 2. Machhakhola Bazaar, with the flood deposit along the river below the market.*

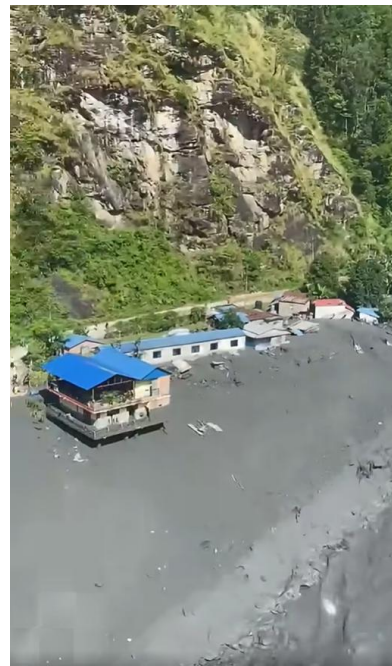
*Photo 3. Buildings standing in debris and mud left by the flood.*

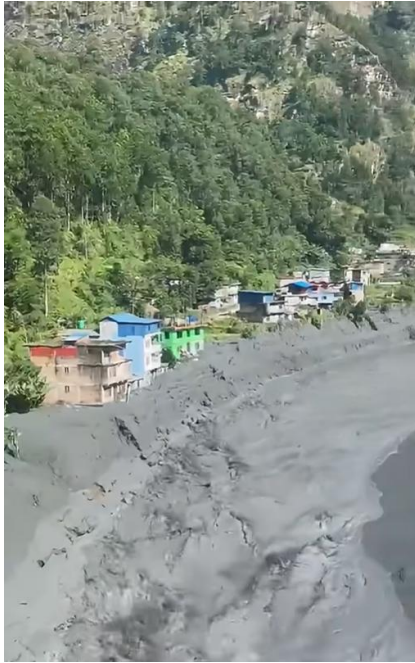
*Photo 4. Houses along the riverbank, with the debris deposit reaching their foundations.*

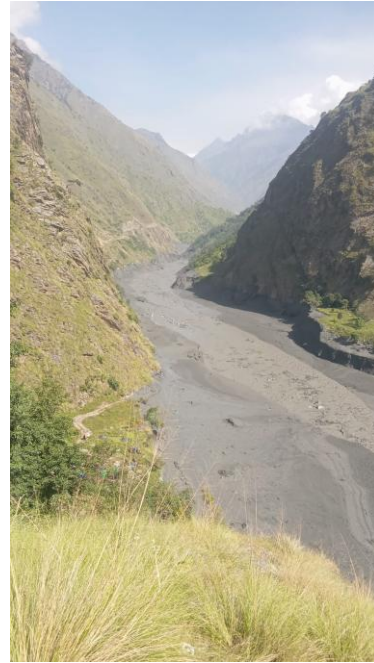
*Photo 5. The Budhi Gandaki valley after the flood, the channel filled with debris.*
